Manhole Inspection Summary

Manhole # S31UU1014MH

Insp Date: **3/19/07 12:10 PM**

Location Address: **114 HOMELAND AVE**

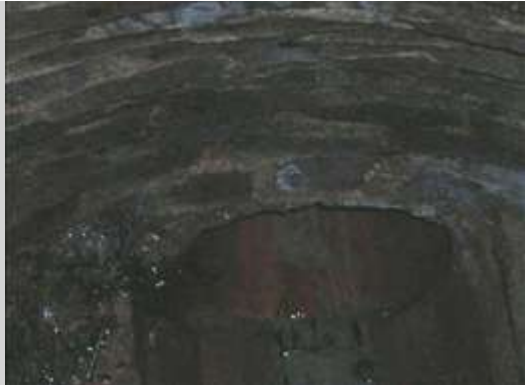
Pipe Out @ 12 O'Clock

8 in. Circular Gravity Sewer

Pipe Material: **Clay** ☐ Pipe Lined

Infiltration: **None** Pipe Seal Cond: **Unknown**
